# UNDERWATER BRIDGE INSPECTION REPORT

STRUCTURE NO. 30508

RUM RIVER

MINNESOTA DEPARTMENT OF TRANSPORTATION  
UNDERWATER BRIDGE INSPECTION

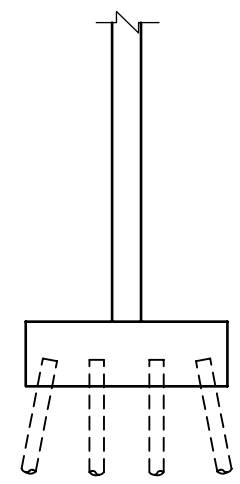
TYPICAL END VIEW OF PIERS

- 1 The channel bottom consisted of 8- to 12-inch-diameter riprap.
- 2 The channel bottom consisted of firm sandy gravel with probe rod penetrations of 2 to 3 inches.
- 3 The concrete surface was in very good and sound condition with light scaling.
- 4 A minor accumulation of 2- to 3-inch-diameter timber debris was observed at the upstream nose.
- 5 The channel bottom consisted of sandy infilling with probe rod penetrations of 6 inches.
- 6 Minor scour depression around upstream nose with 3 foot radius and 1 foot depth.

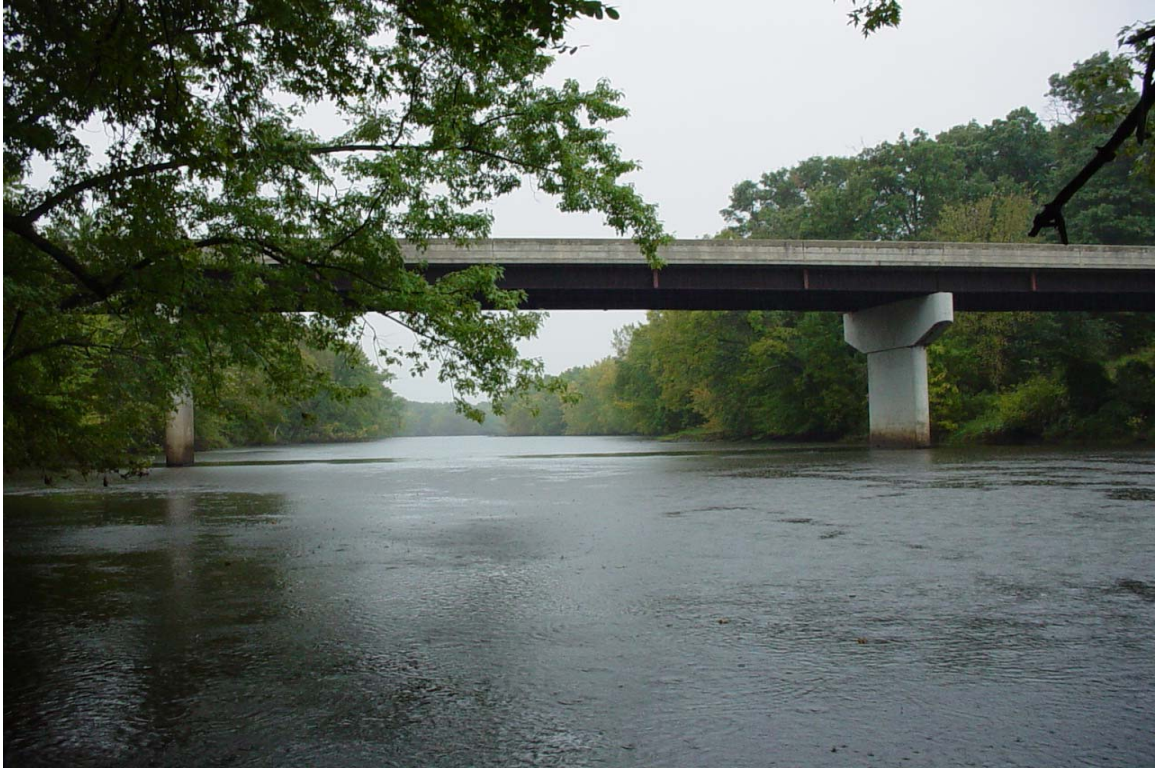
Photograph 1. Overall View of the Structure, Looking West.
